# Failure Analysis of Follower Assembly in the 155mm Artillery Gun

**Abstract:** The follower assembly is a critical component of the 155mm artillery gun, which acts as a safety lock for the trigger mechanism during firing and releases it effortlessly for recoiling. During the firepower mission, issues arose where the follower assembly part would constantly bend or become crooked. This resulted in the roller detaching itself from the assembly and, therefore, reducing the equipment's effectiveness and negatively disrupting the firepower mission. This failure could have major repercussions for both military operations and national defence capabilities. This study investigates the failures and subjects them to macroscopic inspection, metallographic examination, hardness testing, and fractography analysis. A close look at the microstructure showed the existence of three separate layers: an ultra-fine martensitic layer near the surface, a fine martensitic layer closer to the core, and a normal martensite layer covering the rest of the microstructure. The hardness profile also decreases from the near surface to the core of the follower (part of the follower assembly). An analysis using

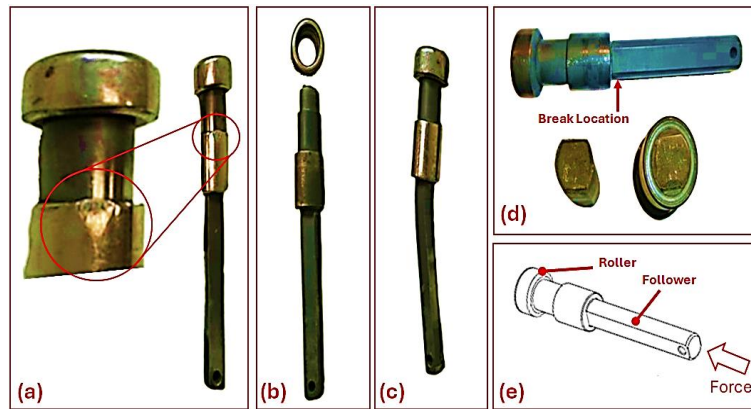
**Figure 3.** Types of failure: (a) dented body, (b) dislodged roller, (c) bent, and (d), broken followers; and (e) the force direction acted on the follower assembly.

Macroscopic inspection was conducted to briefly evaluate the presence of any defects, such as corrosion, misalignment, cracks, and physical damage. Generally, the follower assembly has two components: the follower and roller (Figure 3(e)). A visual inspection categorises the samples into four types of failure, as illustrated in Figure 3 (a) dented body, (b) dislodged roller, (c) bent follower (two samples), and (d) broken follower. All these failures result in disruptions in firepower missions.

Figure 3 (e) identifies the firing force's direction as straight along the follower assembly. All samples were observed to exhibit impact, bent, or broken marks approximately at the same location (Figure 3 (d)). Further investigation indicated that the force at this location was most probably due to the recoiling force (Ibrahim Doruk *et al.*, 2010; Li *et al.*, 2021).

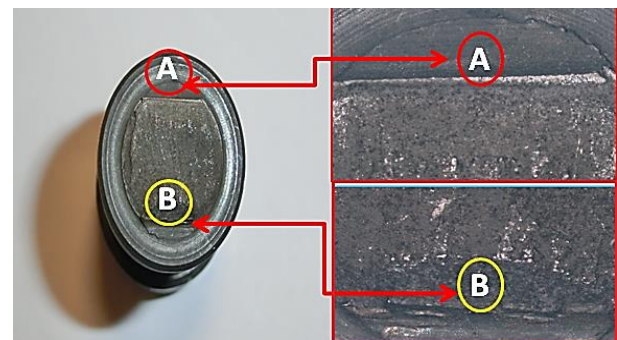
Further inspection with lower magnification was performed to detect defects, such as cracks, porosity, surface irregularities, or inclusions, that are not easily visible with the naked eye. Examining the broken (fracture) sample revealed two rupture regions, indicated by a flat surface with minimal deformation and sheared marks (Figure 4). Regions A and B are the initial and final fracture regions, respectively.

**Figure 4:** Macroscopic image of the broken follower with fracture regions A (initiation) and B (final).

This finding concluded that the specimen is a relatively tough material, having undergone extreme force prior to fracture. The crack propagation was not clearly visible at the macroscopic level, suggesting that the sample might possess exceptional mechanical properties through comprehensive material improvement, alloying addition, mechanical working, or microstructure manipulation (William D & David G Rethwisch, 2020). The material may exhibit ductility in the sample due to its ability to bend prior to fracture, as evidenced by the availability of a bent sample, and the absence of macroscopical brittleness. The next investigations provide further confirmation.

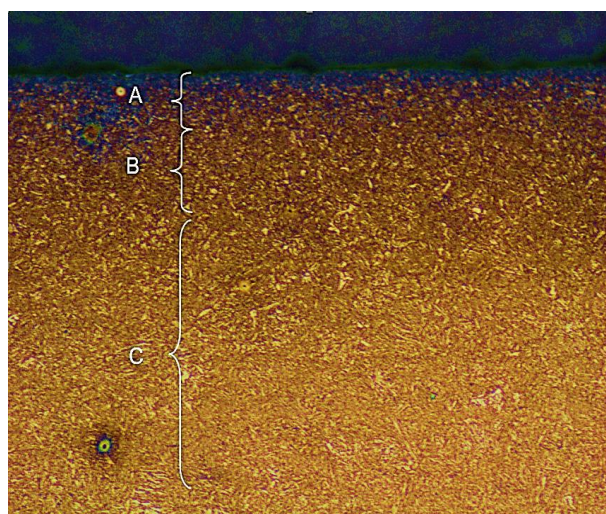
The test (Figure 5) showed three different layers of phases in the microstructure: ultra-fine martensitic (near the surface), fine martensitic (towards the core), and normal martensite (the rest of the microstructure of the material). These changes occur due to the alteration of the ultra-fine martensitic composition in the layers during material treatments. The surface cools down faster than the core, creating a higher martensitic transformation on the surface and a softer ferrite or pearlite microstructure in the core (Karroum *et al.*, 2024). This confirms that the follower underwent quenching and tempering processes, including heat treatment, after the machining process.

**Figure 5:** Metallographic examination (at 200x magnification) revealed (A) ultra-fine martensitic, (B) fine martensitic, and (C) normal martensitic regions. Region (A) is near the surface.

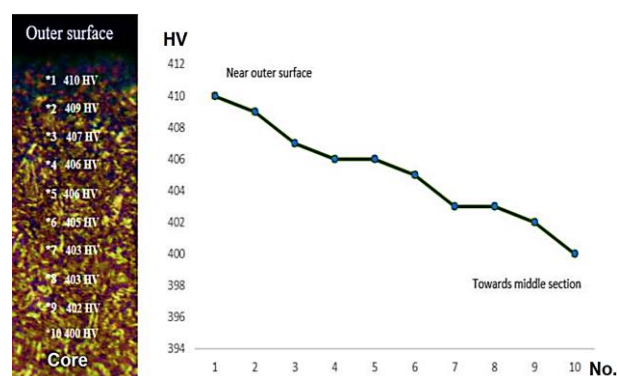
**Figure 6:** The result of the hardness test (Vickers) on a cross-sectioned sample, tested from the near surface to the core with the ASTM E384-17 standard.

The test result presented in Figure 6 showed that the hardness reduces from outer to inner layers. Variations in the ultra-fine martensitic composition between the layers following heat treatments could potentially explain this. The previous metallographic examination concluded a similar finding (Sultan *et al.*, 2024).

Based on this finding, the authors recommend enhancing the heat treatment process of the follower to boost the material's strength and toughness by manipulating the quenching and tempering parameters, such as cooling medium, temperature, and time (Sultan *et al.*, 2024; Tikhe *et al.*, 2023).

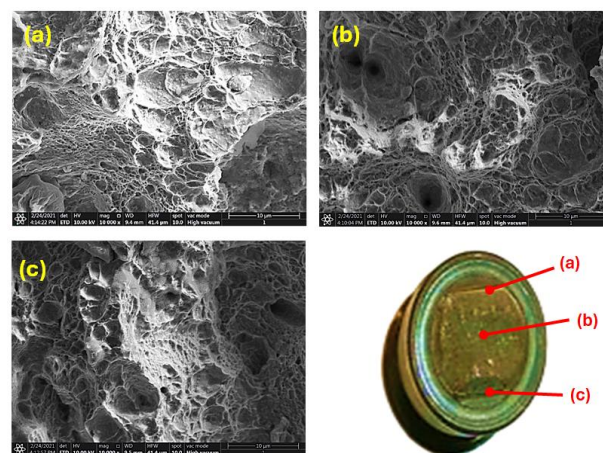
The scientific APREO field emission scanning electron microscope (FESEM) was utilised for this analysis, capturing images of the fracture surface on the broken sample in three regions, as shown in Figure 9. The fractography revealed that the material underwent overload ductile fracture, with dimples dominating the microstructure, as predicted by the previous macroscopic inspection. The varying dimple sizes indicate the ductility and toughness of the material, where larger dimples mean low stress concentration (high energy absorption during failure) and extensive plastic deformation and, therefore, high ductility and low toughness (low hardness). The images showed an increase in dimple size from the initiation (Figure 9 (a)) to the final (Figure 9 (c)) rupture regions, which suggests a reduction in toughness as the material transitions from constrained to less constrained stress states due to plastic deformation differences

in those regions. Additionally, numerous small, round, or elongated dimples indicated that the sample experienced overload prior to fracture, similar to previous claims in macroscopic inspection

Figure 9: Fractography of follower with 10,000x magnification at the fracture regions: (a) initiation, (b) middle, and (c) final.
