# Failure Analysis of Follower Assembly in the 155mm Artillery Gun

**Abstract:** The follower assembly is a critical component of the 155mm artillery gun, which acts as a safety lock for the trigger mechanism during firing and releases it effortlessly for recoiling. During the firepower mission, issues arose where the follower assembly part would constantly bend or become crooked. This resulted in the roller detaching itself from the assembly and, therefore, reducing the equipment's effectiveness and negatively disrupting the firepower mission. This failure could have major repercussions for both military operations and national defence capabilities. This study investigates the failures and subjects them to macroscopic inspection, metallographic examination, hardness testing, and fractography analysis. A close look at the microstructure showed the existence of three separate layers: an ultra-fine martensitic layer near the surface, a fine martensitic layer closer to the core, and a normal martensite layer covering the rest of the microstructure. The hardness profile also decreases from the near surface to the core of the follower (part of the follower assembly). An analysis using

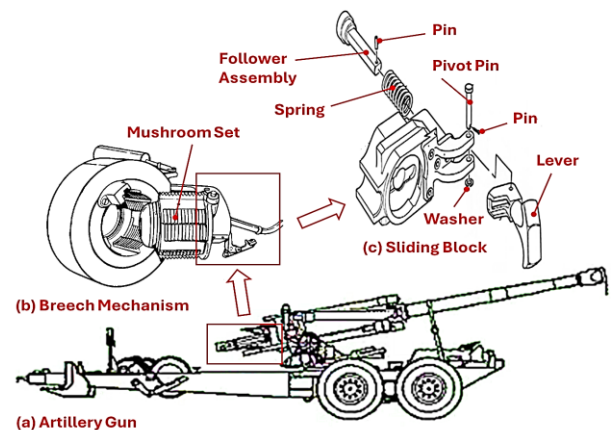
**Figure 2:** Artillery gun (a) main structure, (b) breech mechanism and sliding block sub-assemblies, and (c) its components (including follower assembly).
